Inspection Summary

Chick Torrence
1124 Union Mill Rd.
Mt. Laurel, NJ 08054
856-234-7787
NJ License # 24GI00059600

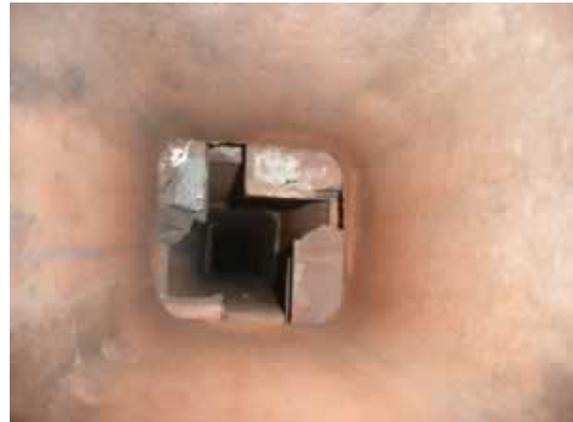
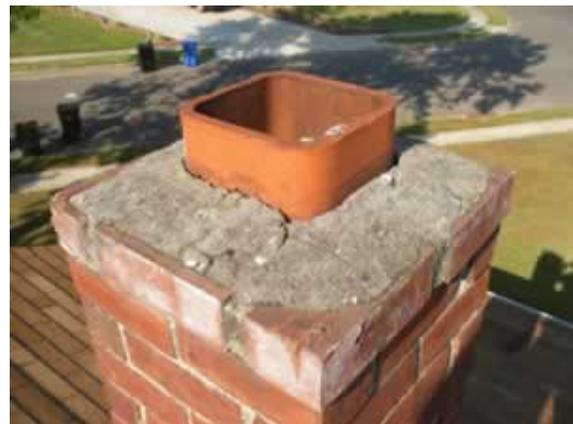
When slight pressure was applied by hand, the chimney experienced some movement, indicating a possible fracture.

Some damaged bricks were noted.
We recommend repairs.

The clay tile flue liner is displaced (separated). This will allow deadly carbon monoxide gas (CO) into the living space.
Further evaluation by a qualified chimney contractor is recommended.

The chimney wash cap is damaged . This is a cement application at the top of the chimney that surrounds the flue .

A chimney screen cap was not in place. This is a caged type device with a cap at the top of the flue. To prevent the intrusion of rain, snow, rodents and fowl, we recommend installing a chimney screen cap.

We recommend a qualified chimney contractor evaluate for repairs.

To prevent water intrusion, we recommend repairs by a qualified masonry contractor.

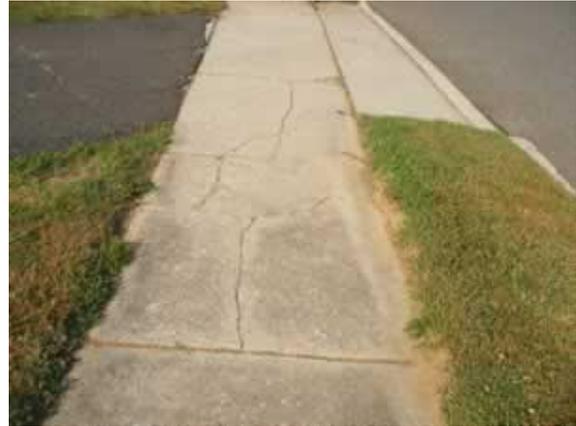
Areas of damaged and uneven sidewalk and front walk were noted. These areas present a trip hazard. We recommend a qualified contractor evaluate for repairs.

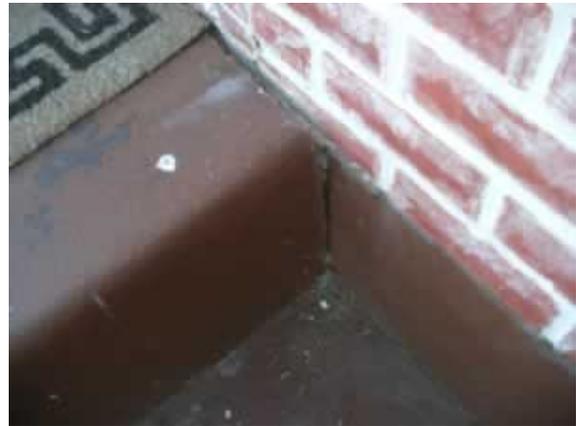
The front porch has rotated (separated) from the foundation.

We recommend repairs by a qualified contractor.

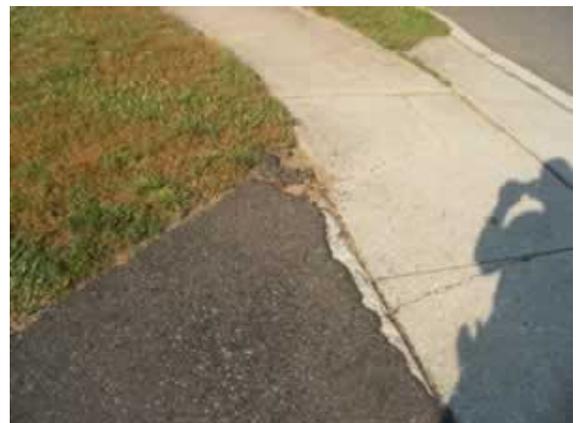
Deterioration of asphalt driveway was observed. These areas are trip hazards.

We recommend repairs by a qualified contractor.

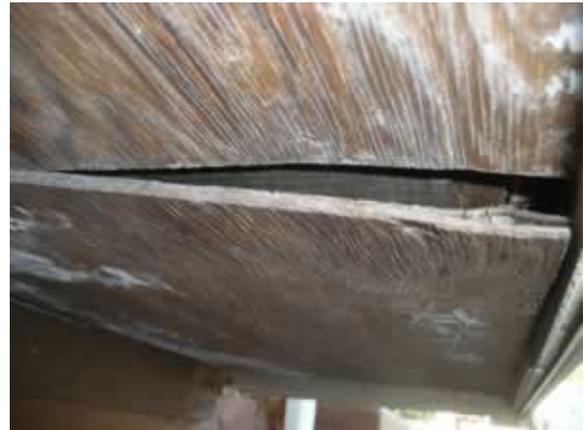
The sheathing at the front right "bump out" is separated, this will allow the intrusion of vermin and insects. We recommend repairs and capping with aluminum.

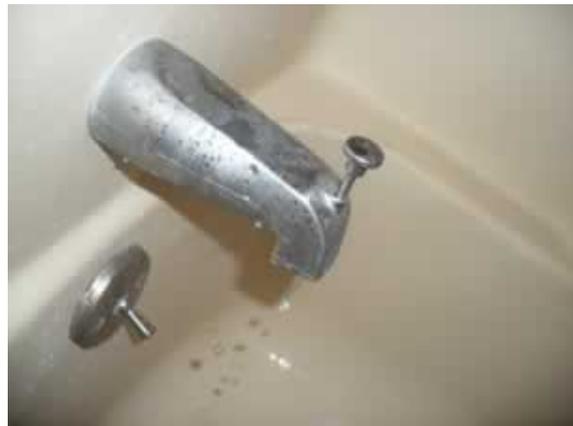
Tub stopper not working. We recommend repairs by a licensed plumber.

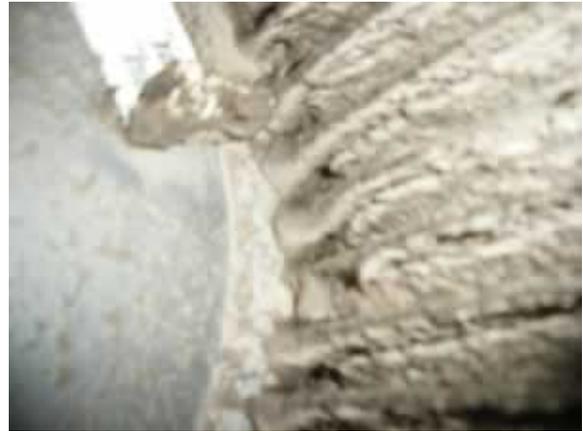
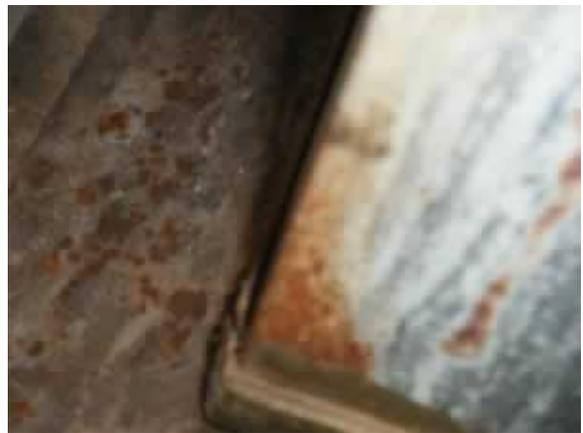
The duct work is rusted at multiple areas. This is most likely from condensation.

We recommend a qualified heating contractor evaluate for repairs.

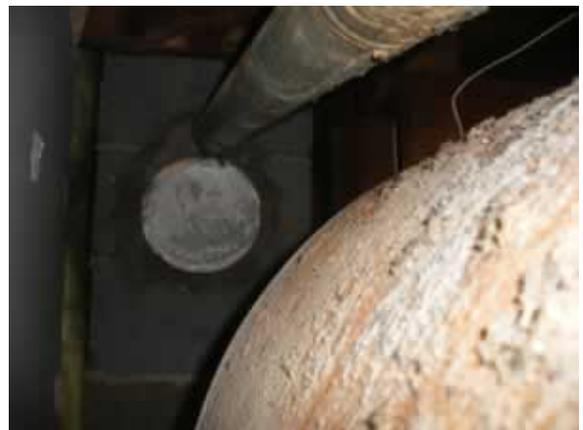
Flue piping is showing evidence of rusting / spillage. This is most usually from condensation - the hot air from the furnace meeting the cold air in the chimney and condensing or a possible blockage in the flue or chimney. Condensation is even more of an issue with an exterior chimney (the chimney is colder and condensation occurs more rapidly). A flue or chimney blockage will cause poisonous carbon monoxide gas to enter the living space.

cause of poisoning deaths in the United States. The packing around the flue piping at the chimney connection is deteriorated. To prevent the escape of harmful carbon monoxide gas, we recommend adding fresh packing material (furnace cement).

We recommend a qualified heating contractor evaluate for repairs.

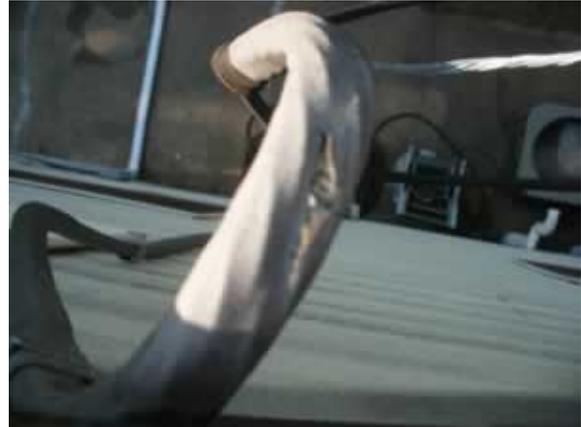
Open splices (exposed wiring connections) were observed in the crawl space. For safety, we recommend these connections be performed inside an approved work box with a cover. We recommend a qualified licensed electrician evaluate for repairs .

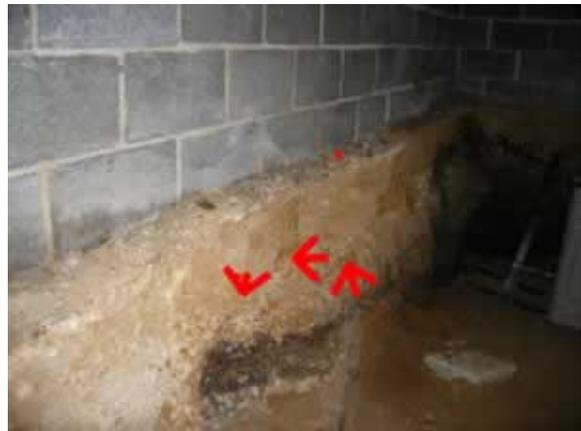
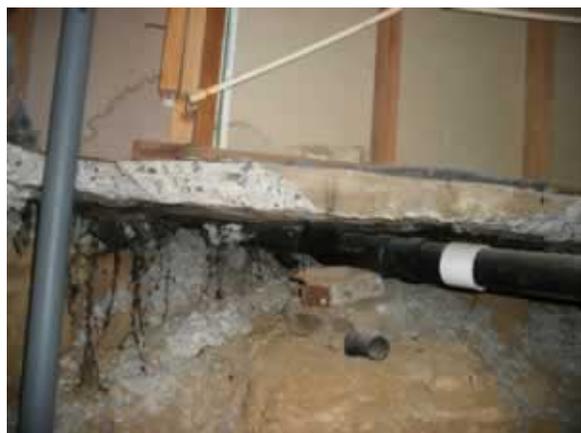
The foundation walls have been dug out to under the footings, the block columns have exposed footings, temporary floor jacks were noted, a scissor jack and major erosion was noted under the slab. We recommend a full evaluation of all structural components by a licensed engineer.

Termite Shelter Tubes were noted on the crawl space foundation walls and termite damage was noted at the rear basement door frame .

We recommend a termite treatment to prevent further infestation / damage. We recommend all repairs be completed by a qualified contractor. EXPECT POSSIBLE HIDDEN DAMAGE !!!

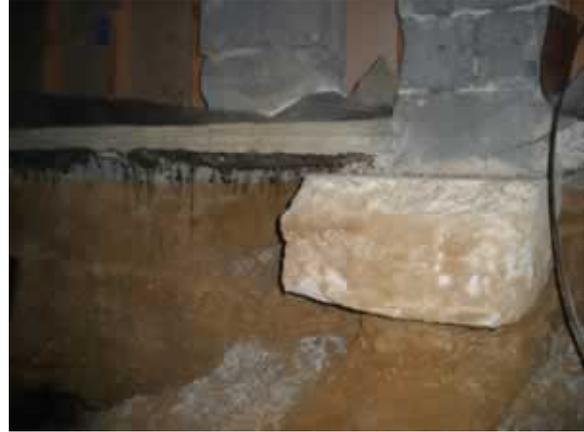
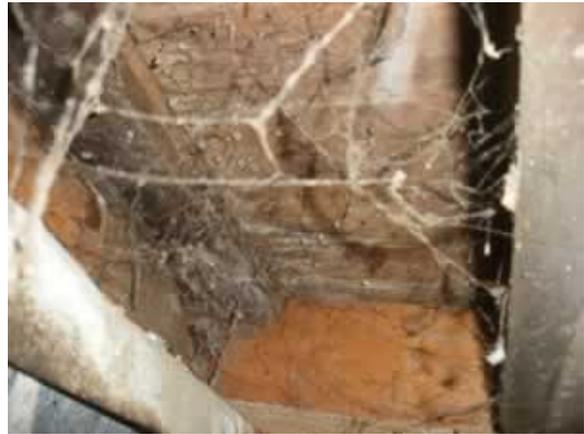
The termite evidence does not include hidden damage that may exist. This inspection can not conclude any amount of damage that exists inside an area that is not visible to the inspector. Efflorescence was noted on the foundation walls. This is a whitish mineral deposit often seen on the interior of foundation walls. The presence of

efflorescence indicates water penetration, although it does not tell a great deal about the severity of the problem or whether the problem is active. As water passes through the wall, it dissolves salts in the masonry, concrete or mortar, so that when the water arrives at the wall surface, it contains a good deal of minerals in solution. The crystalline salt deposit, known as efflorescence, is left as water is evaporated off the wall surface. Since virtually all crawl space walls leak at some point in time, the question is probably not "Will the crawl space leak?" but when. Since 90% of wet basement problems are caused by surface water (rain , snow , roof drainage) collecting around the building, the surface water issues should be addressed first. Proper grading techniques are extremely important and make sure all down spouts have elbows and extenders diverting the water away 6 feet from the foundation and that the proper grading techniques are implemented. Efflorescence can be scraped off and a water proofing paint applied.
