Inspection Summary

Chick Torrence
1124 Union Mill Rd.
Mt. Laurel, NJ 08054
856-234-7787
NJ License # 24GI00059600

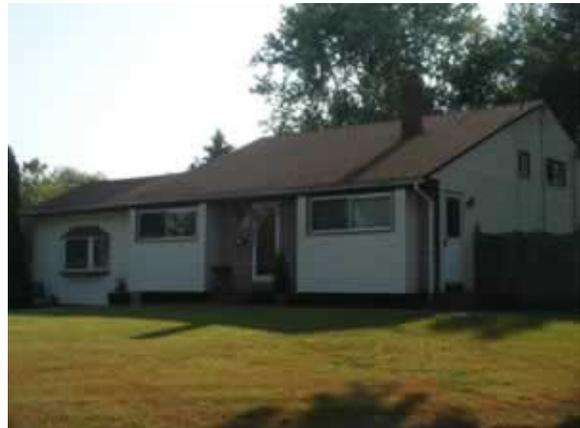
This inspection is not intended to address or include any geological conditions , site stability information or determine the flood plain conditions. For information concerning these conditions, a geologist or soils engineer should be consulted. Any reference to grade is limited to only areas around the exterior of the exposed areas of the foundation or exterior walls. This inspection is visual in nature and does not attempt to determine drainage performance of the site or the condition of any underground piping, including municipal water and sewer service piping or septic systems. Decks and porches are often built close to the ground, where viewing or access is

impossible. These areas as well as others too low to enter, or in some other manner not accessible, are excluded from the inspection and are not addressed in this report. We routinely recommend that inquiry be made with the seller about knowledge of any prior foundation or structural repairs.
